Manhole Inspection Summary

Manhole # S15AA_020MH

Insp Date: **11/19/07 12:55 PM**

Location Address: **REAR OF 1019 ASHBURTON ST**

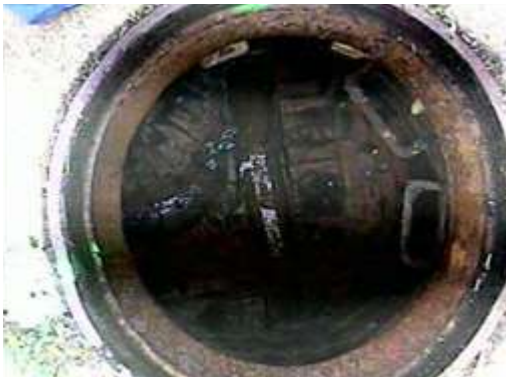
Defect 1

Count: **3** Missing: **0** ☒ **Corroded**

Corroded steps

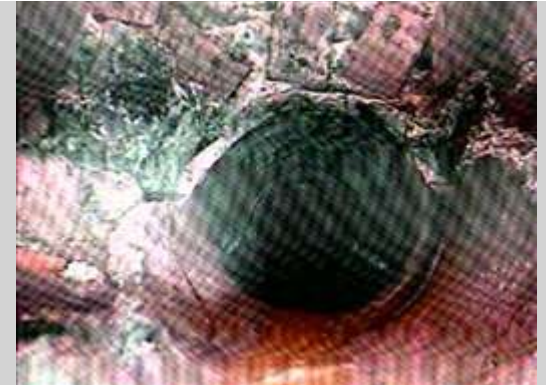
12 O'Clock Outflow

Infiltration: **None** Pipe Seal Cond: **Cracked**

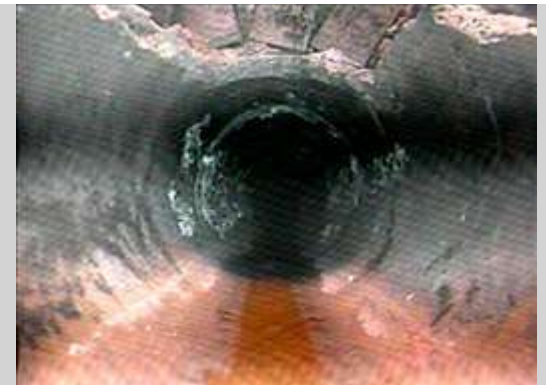
6 O'Clock Inflow

Infiltration: **None** Pipe Seal Cond: **Sound**

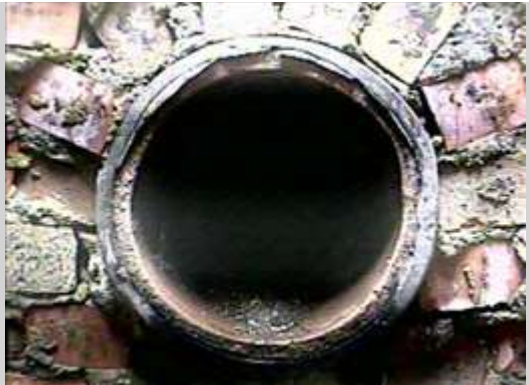
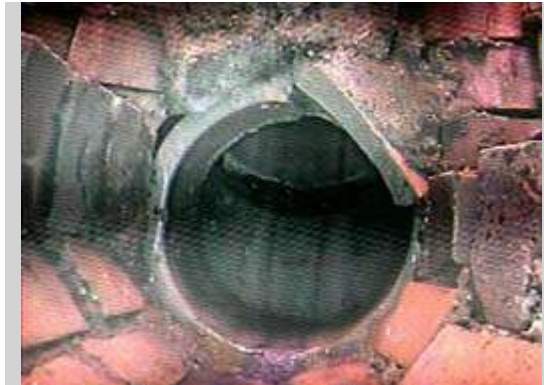
9 O'Clock Inflow

Infiltration: **None** Pipe Seal Cond: **Cracked**

Drop: **Outside Direct**
